Multiple Fatality High-Rise Condominium Fire

Clearwater, Florida - June 2002

Technical Report Series - USFA-TR-148

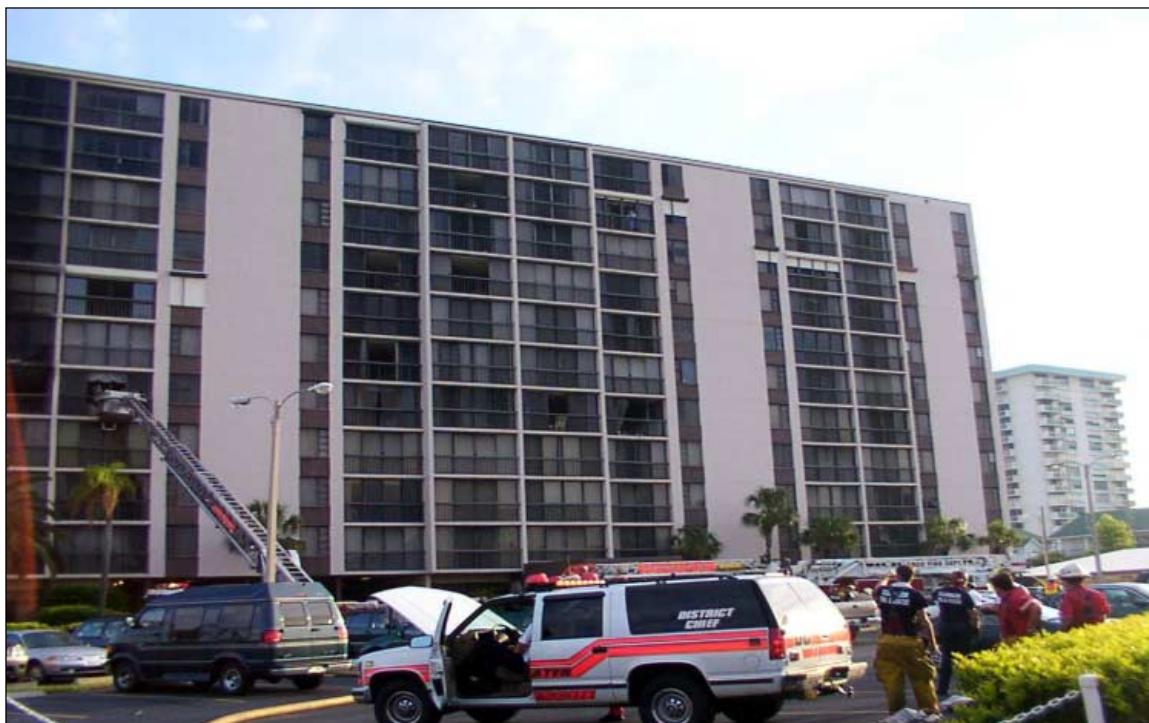
- #2 View of southeast corner
- #3 Note occupants on 10th floor balconies. This provides indication of the narrow depth of balcony landings.
- #4 View of damage to fifth floor hallway.

2. View of southeast corner

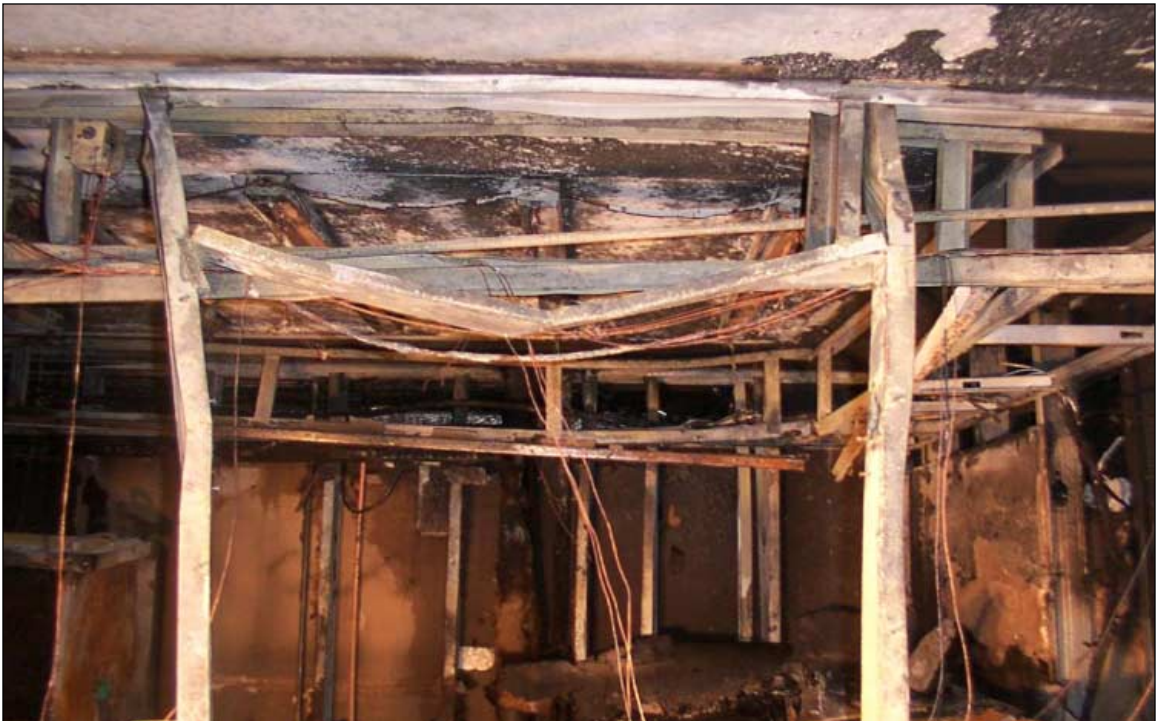
- #10 Area of origin, kitchen of Unit #501.
- #11 Note top of photo: shows concrete floor typical of building construction.
- #12 Interior view of kitchen showing extent of damage.

11. Note top of photo: shows concrete floor typical of building construction.

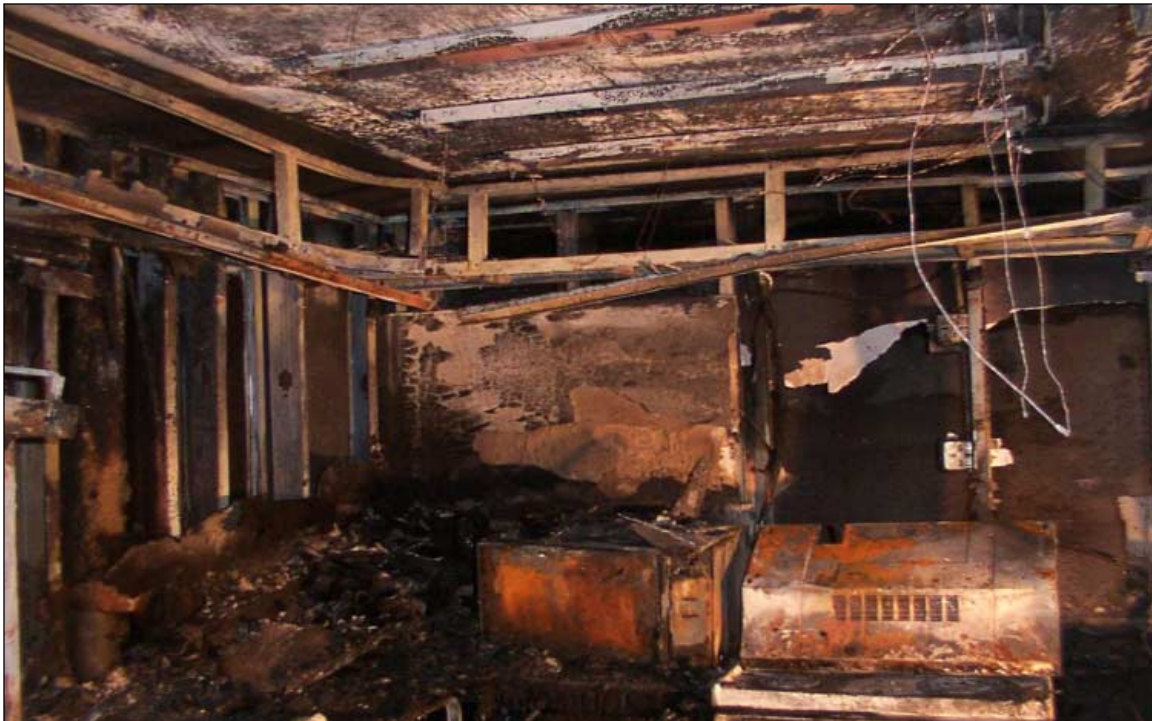
- #13 View of interior of kitchen and ceiling.
- #14 Control valve to central standpipe riser found to be closed during fire.
- #15 Two discharged 5-lb. ABC extinguishers and 1 1/2-inch house line found outside Unit 501.

13. View of interior of kitchen and ceiling.

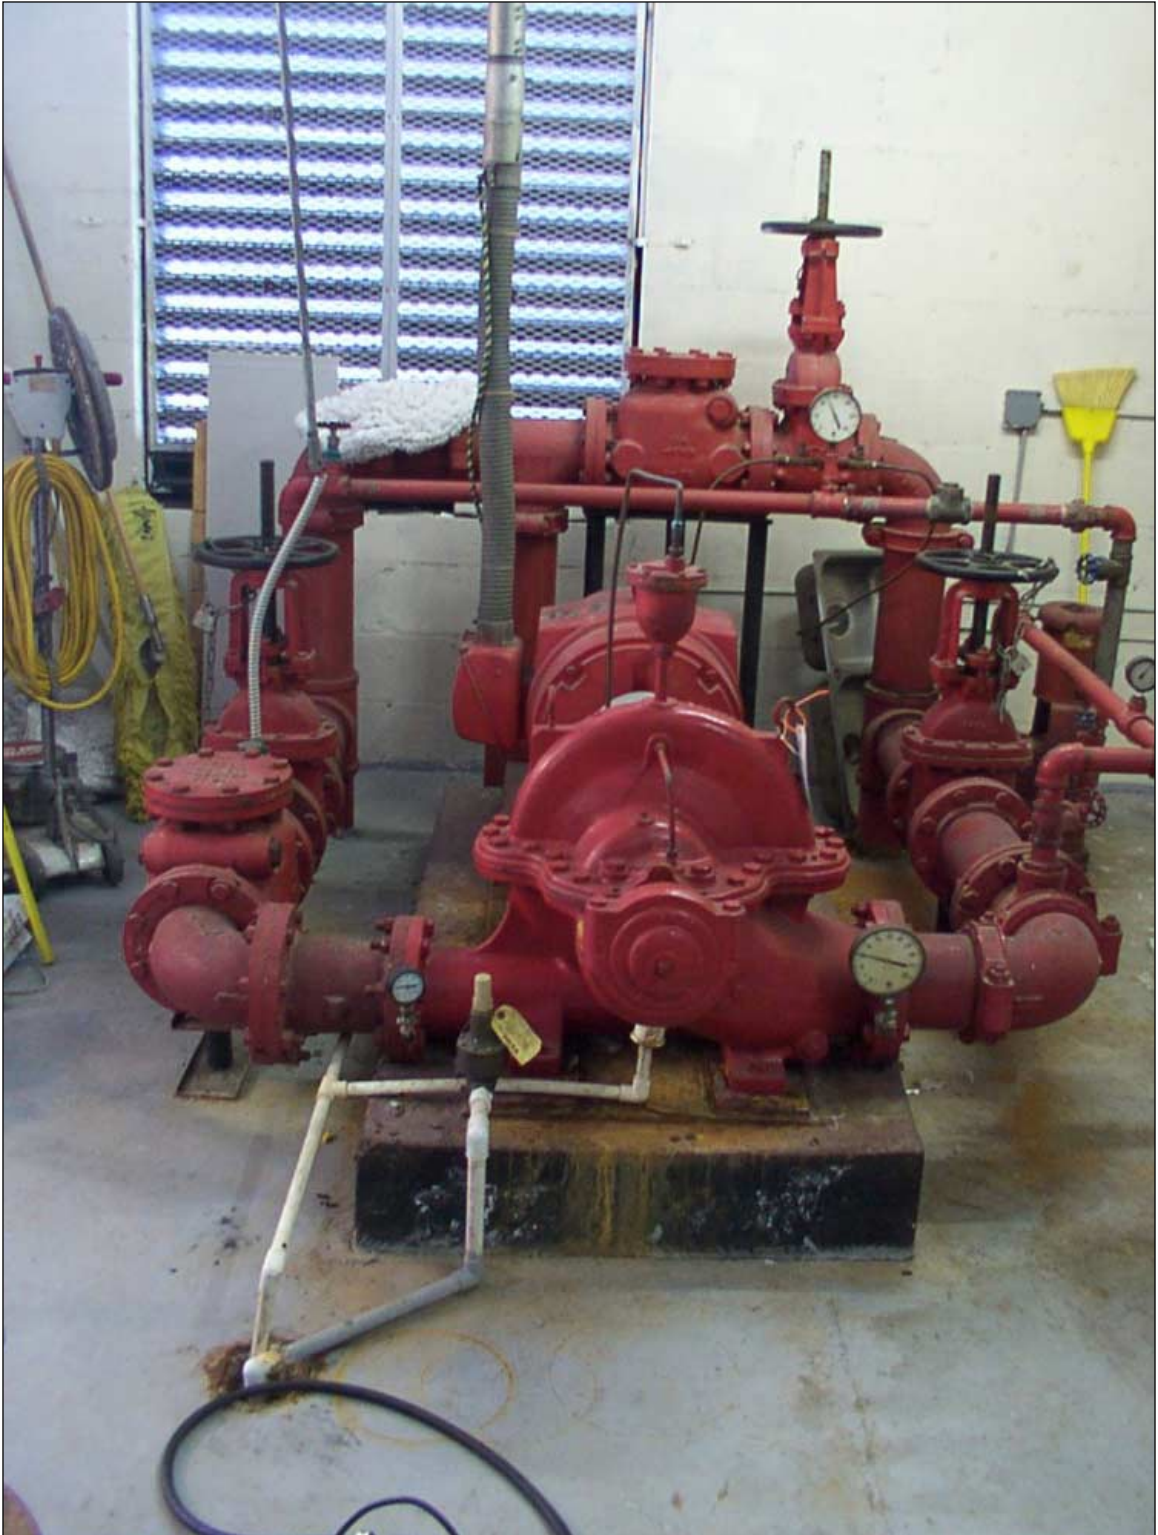
- #16 Hydrant that failed to operate during fire; note parts in background.
- #17 Electrically powered fire pump rate at 1,000 gpm at 90psi.
- #18 Alarm panel located in second floor mechanical room.

17. Electrically powered fire pump rate at 1,000 gpm at 90psi.

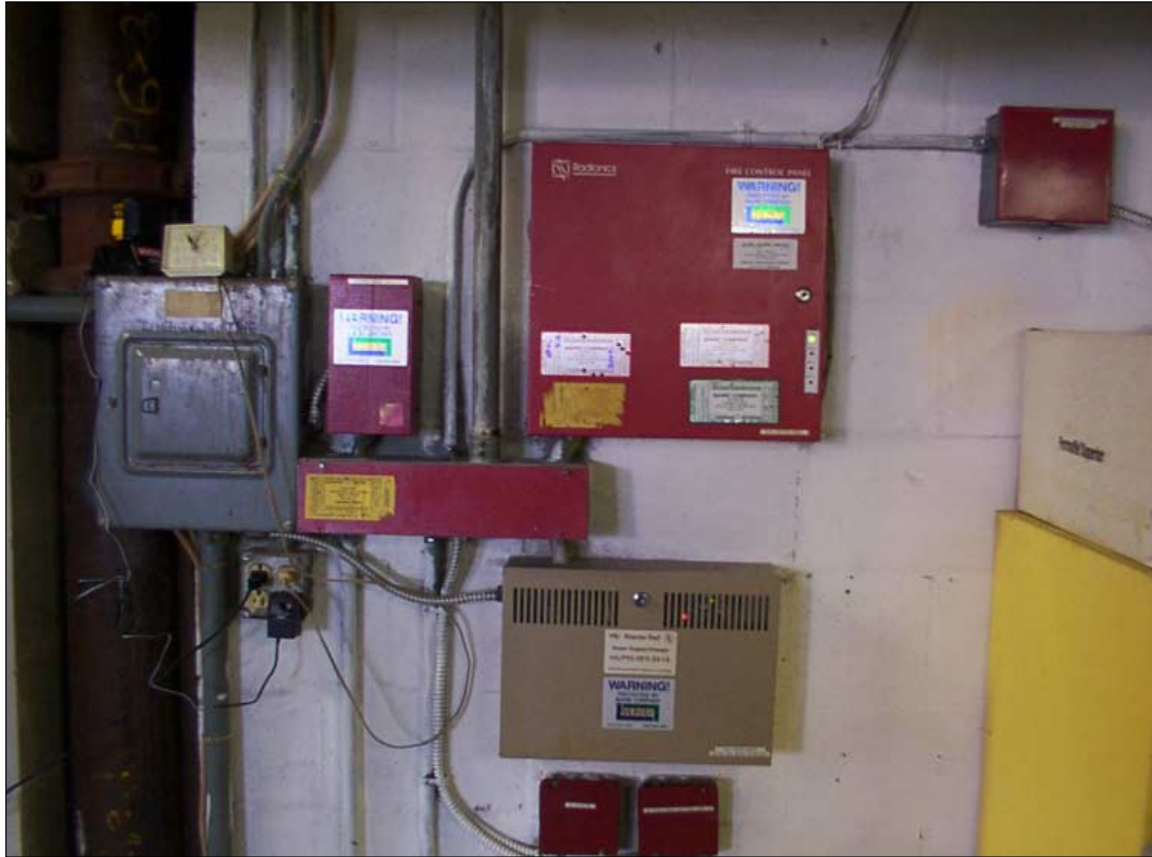
18. Alarm panel located in second floor mechanical room.

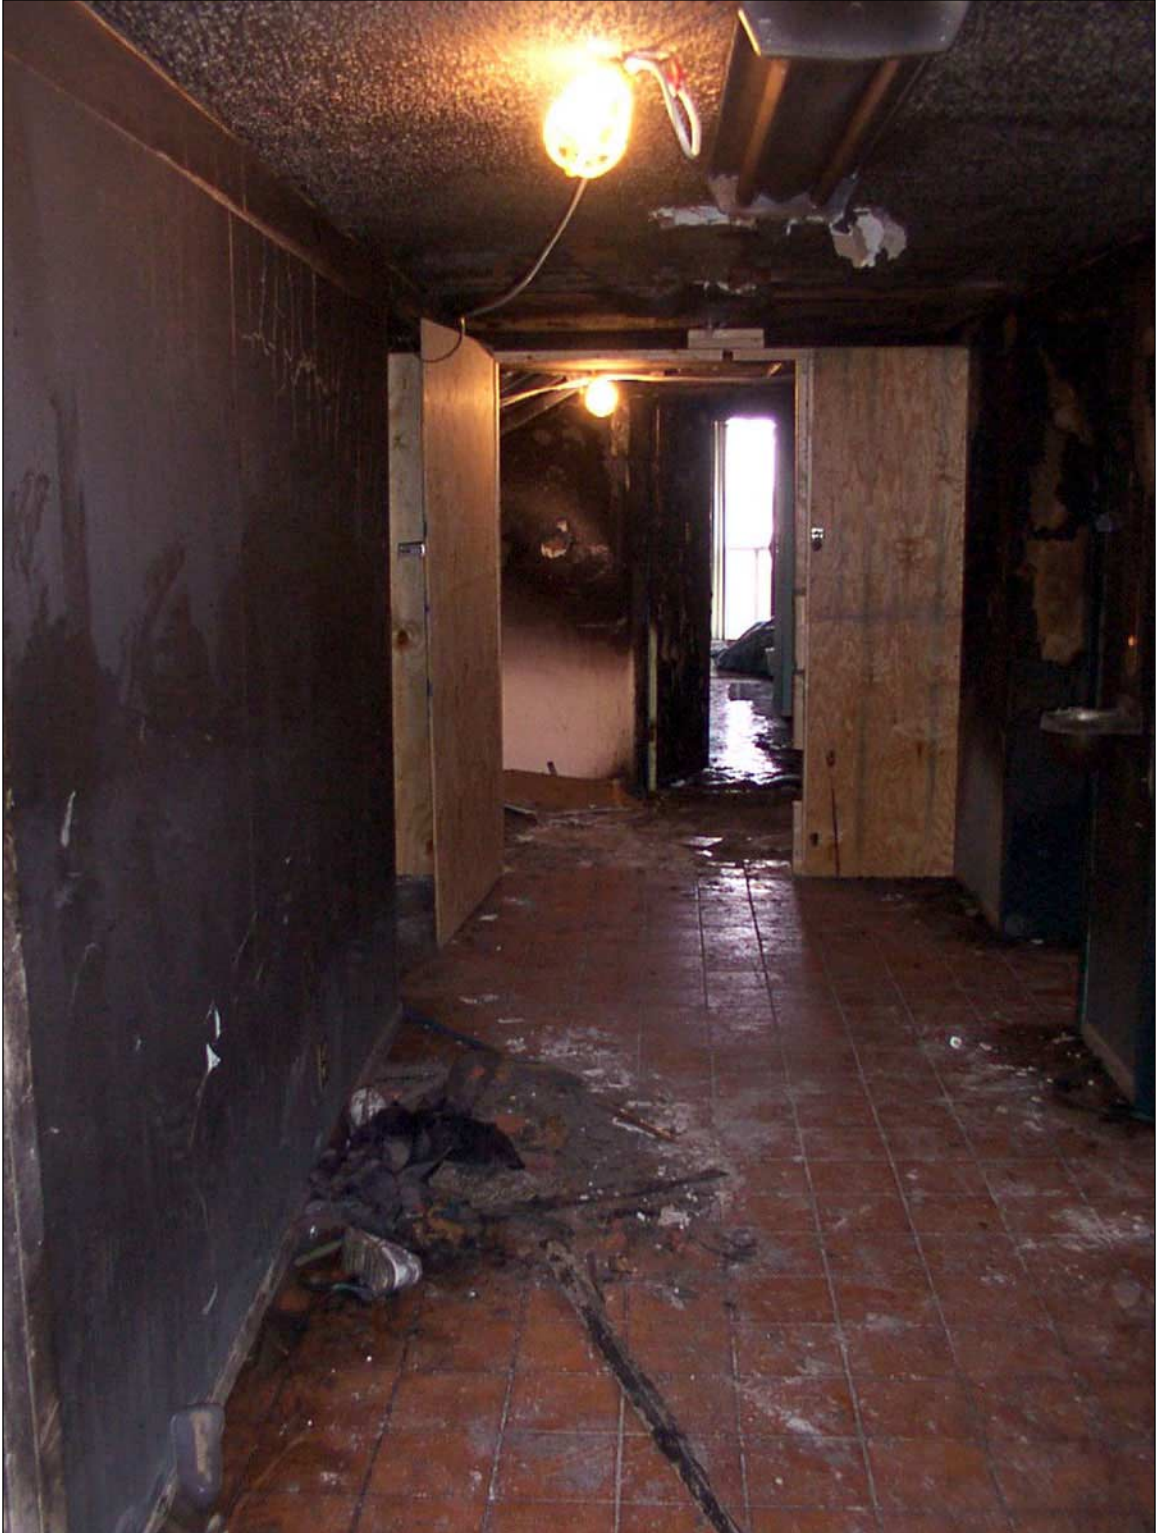
- #19 Extent of damage to fifth floor hallway.
- #20 Damage to hallway east of elevators, note less damage midpoint to floor.
- #21 Fifth floor elevator lobby

21. Fifth floor elevator lobby

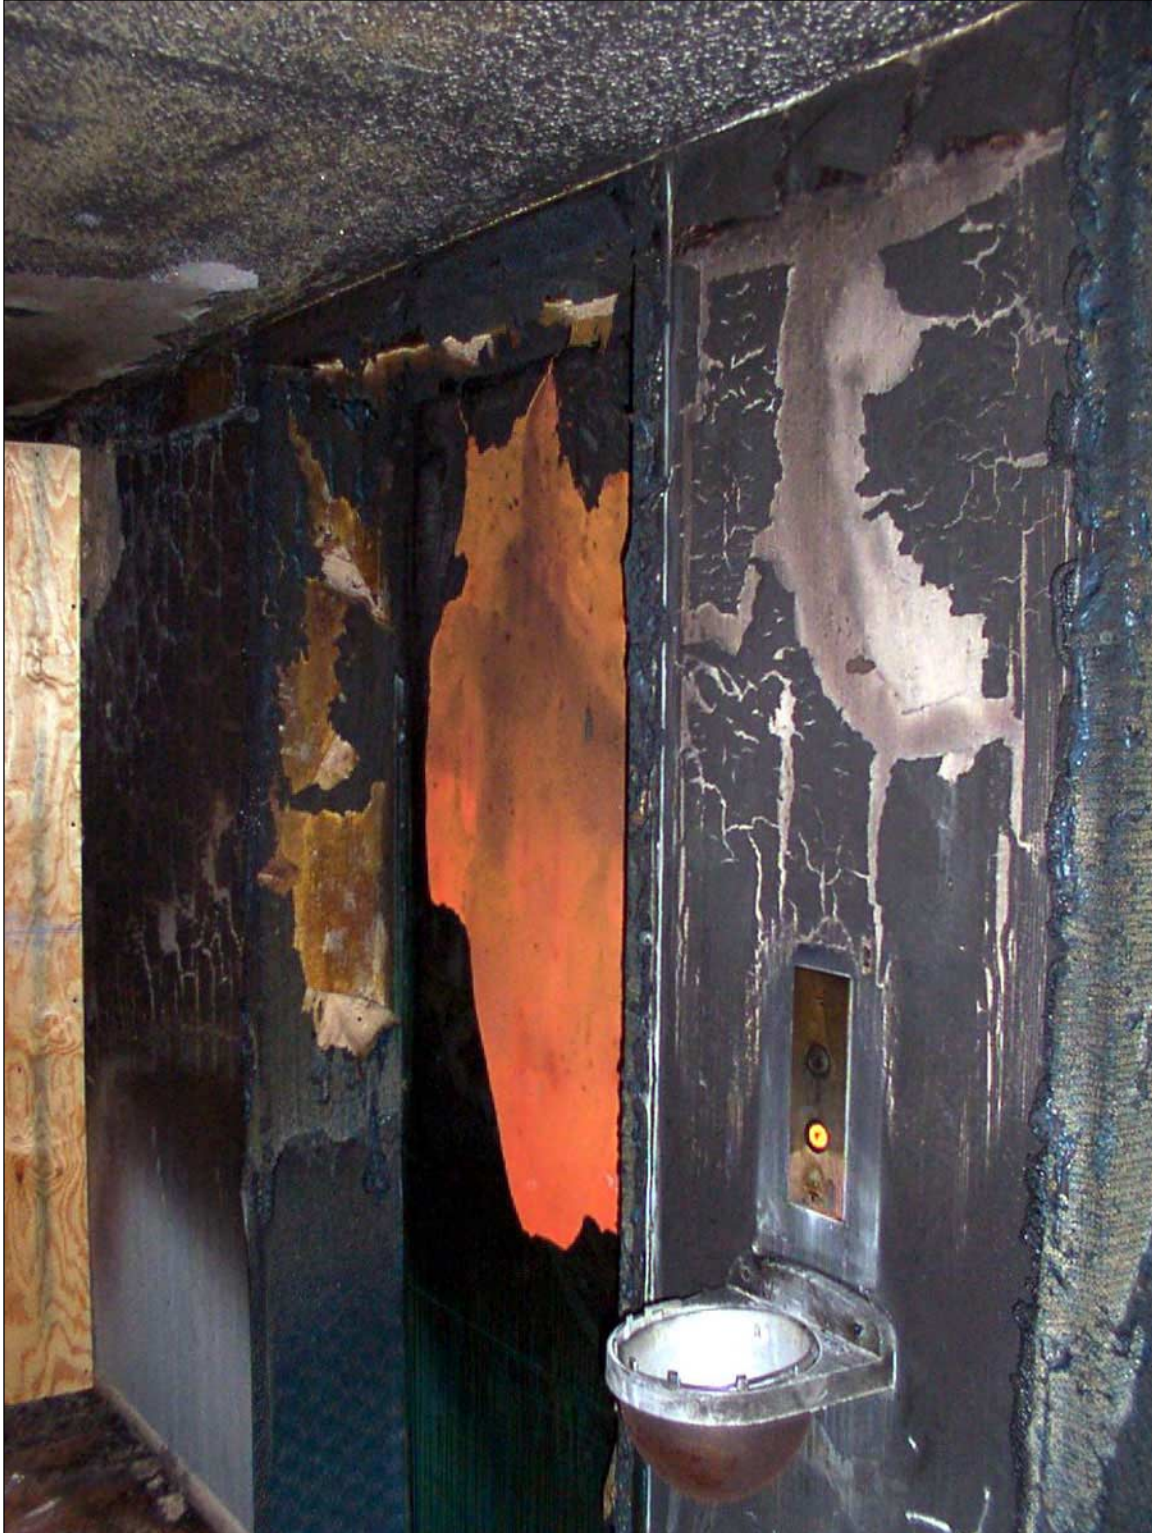
22. Fifth floor elevator doors and call buttons
